No quake zone?

Keowee, Hartwell dams built to take the shake

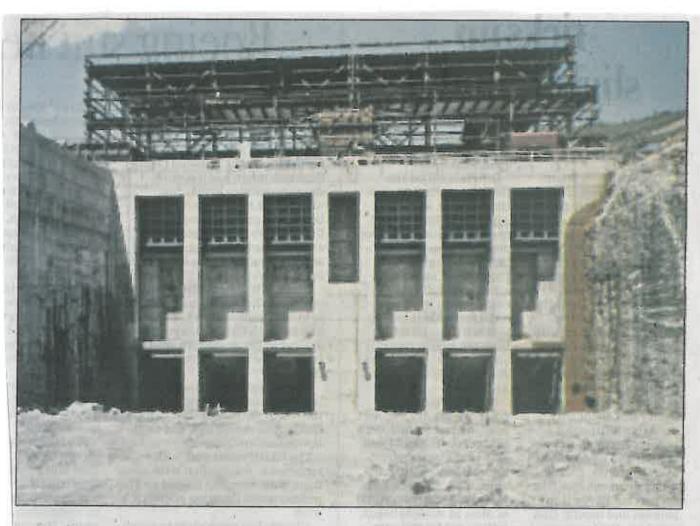
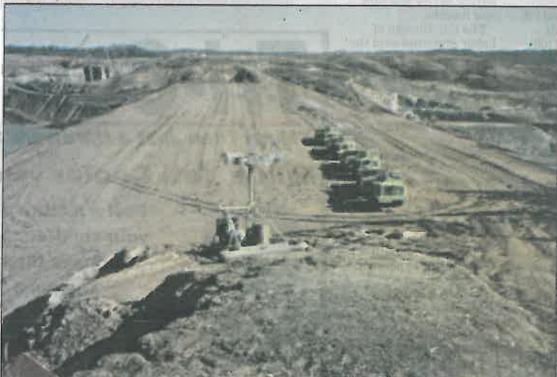
Above, work on the Keowee Dam spillway was well under way when this photo was taken in 1968. Left, 2 million cubic yards of dirt were used for the 3,500foot Keowee Dam, which is 155 feet tall and 800 feet wide at its base.

It is 155 feet tall, 800 feet wide at its base and narrows to 20 feet wide at the top. Two large turbines power generators that create electricity.
